## HIGHLIGHTS FROM FEMA REPORT VS WILLOWBROOK AND

### FEMA PICTURES - Lack of adequate connections

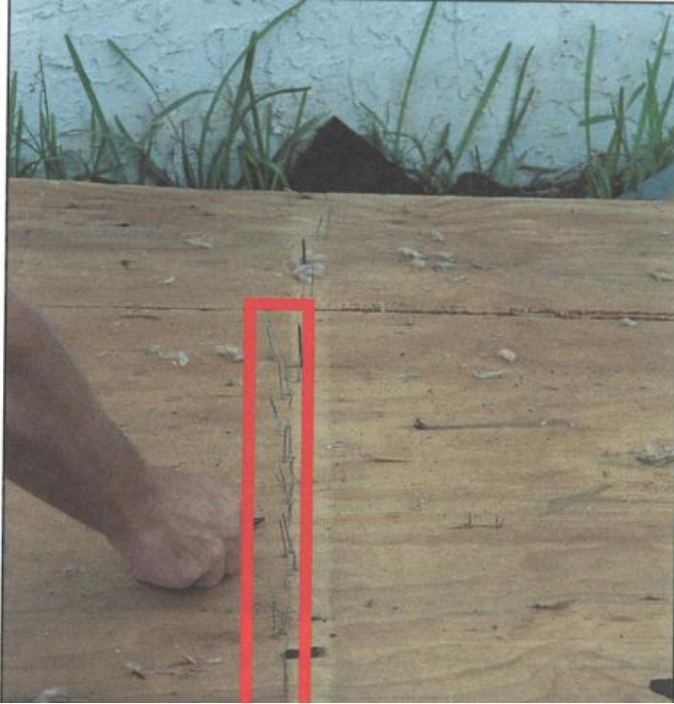
FIGURE 11.  
*Roof sheathing found in debris. Staples were off-line and therefore not connected to supporting truss top chord.*

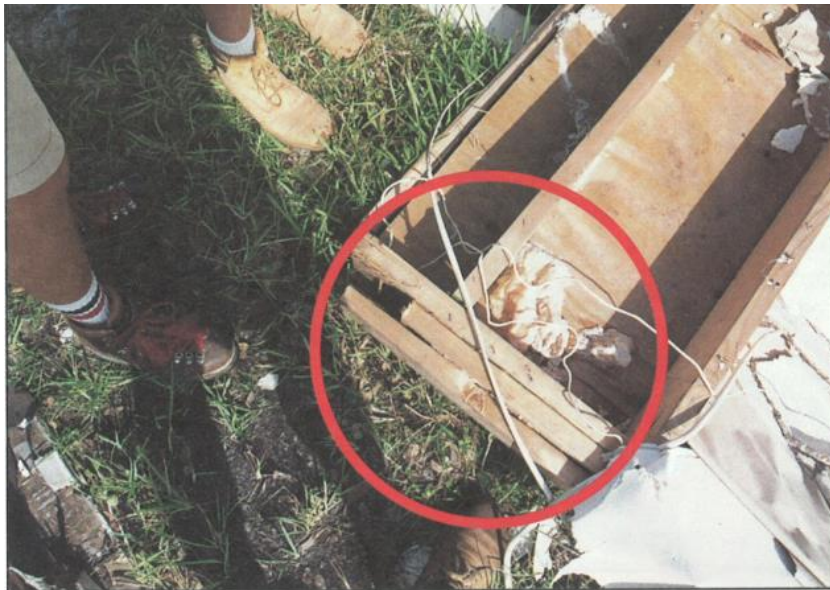
FIGURE 10. *Top plate splice not able to transfer horizontal loads.*

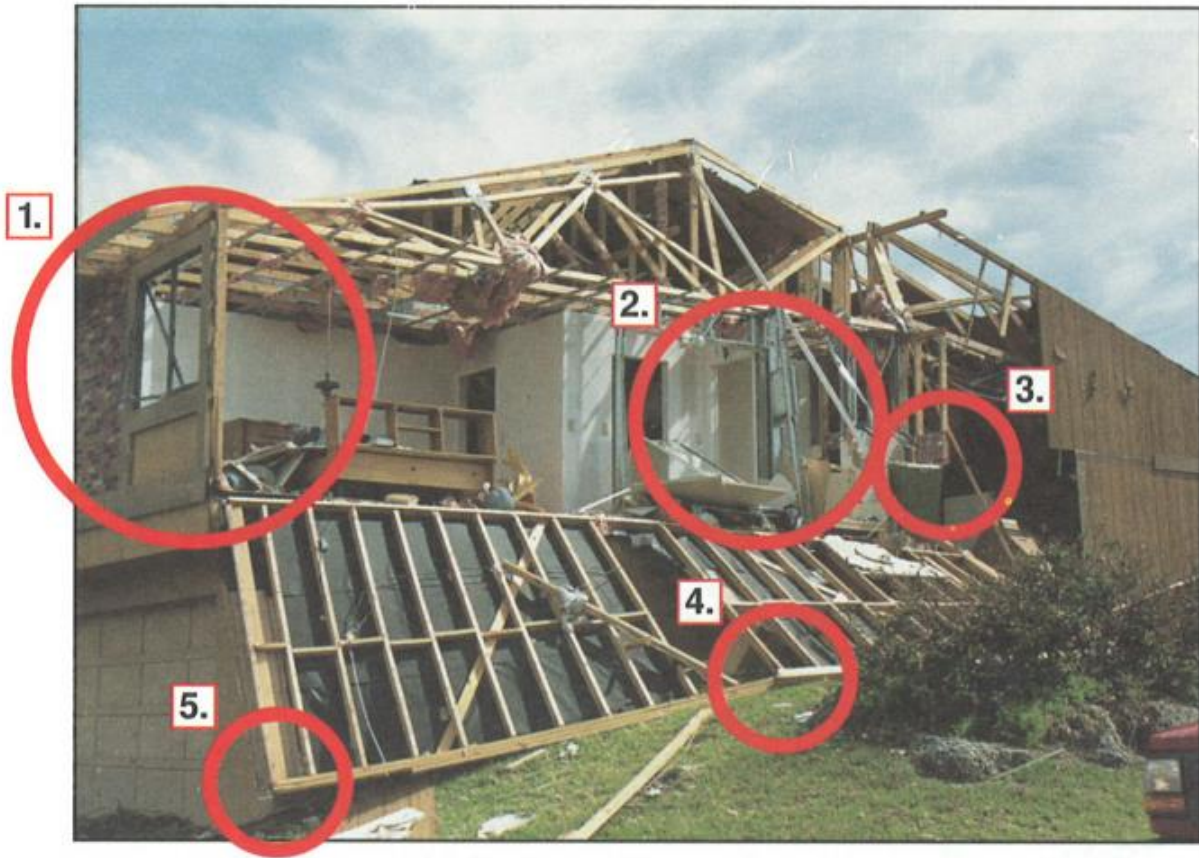
FIGURE 9. *Failure of non-loadbearing wall. Connections of exterior wall were not adequate.*

- 1. End column separated from roof.*
- 2. Load transfer from outside wall to interior shear wall inadequate.*
- 3. Beam separated from beam seat/connector.*
- 4. Improperly spliced composite tie-beam/connector.*
- 5. End of top plate connection inadequate.*

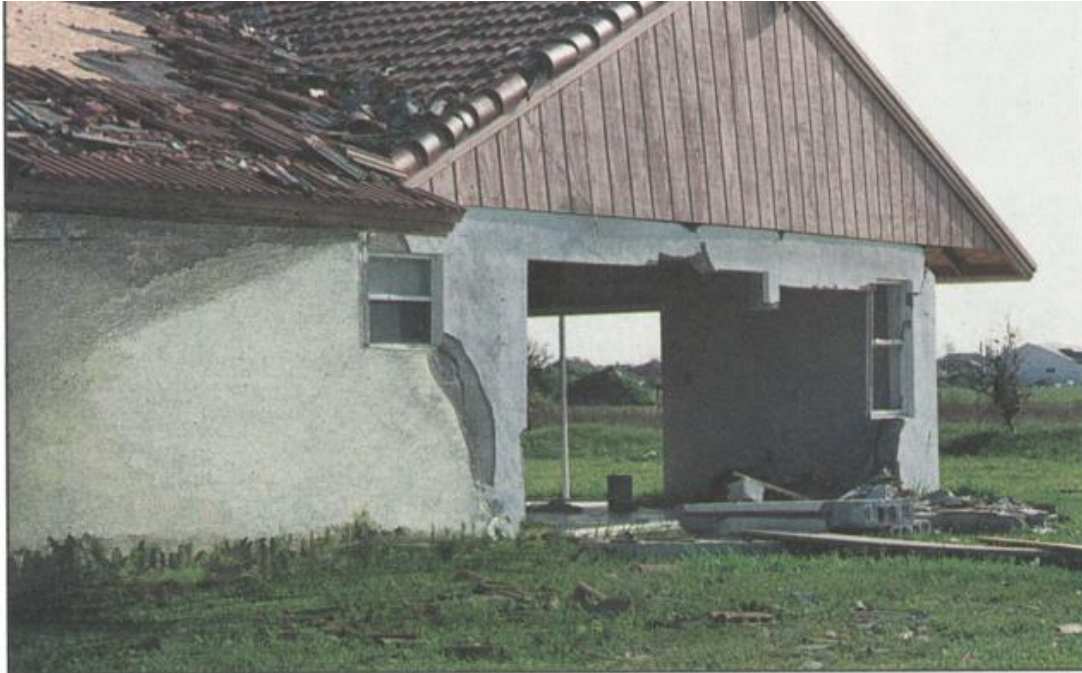
FIGURE 15. *Masonry construction building. Wall separated from building envelope due to inadequate vertical wall reinforcing in connection to horizontal tie-beam.*

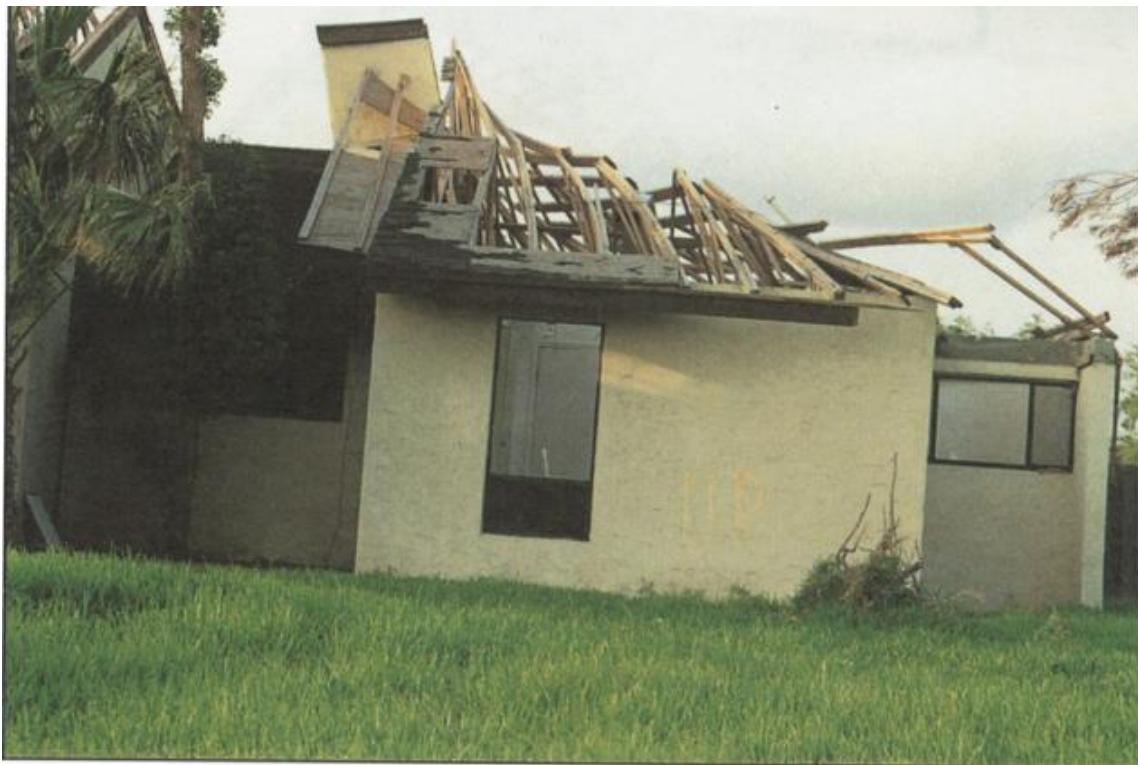
FIGURE 14. *Roof structure failure due to inadequate bracing.*

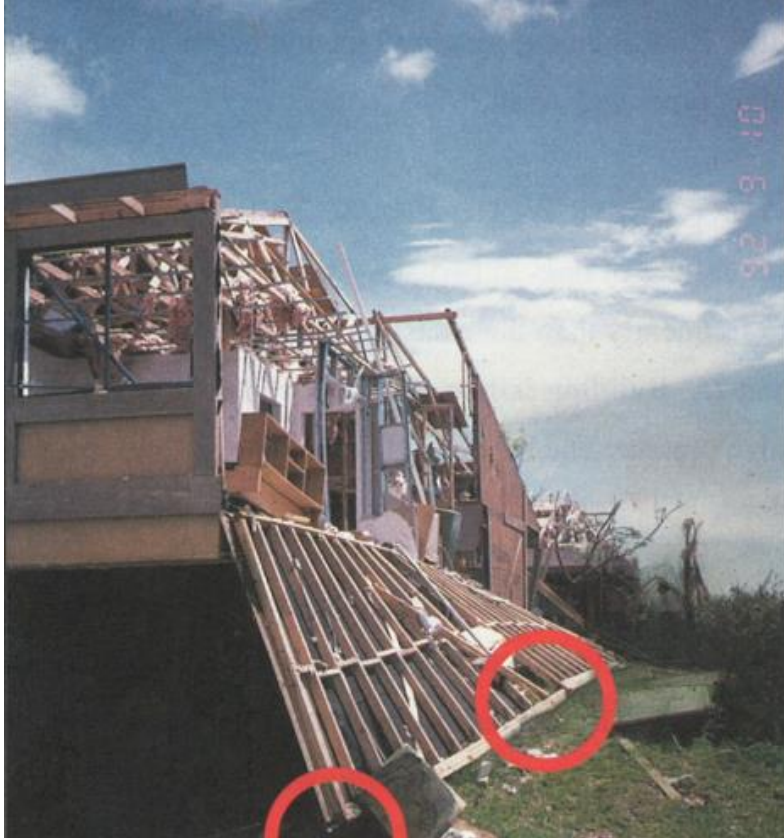
*Exterior wood-frame non-loadbearing wall. Transfer of wind forces from wall to adjoining structure was not sufficient.*

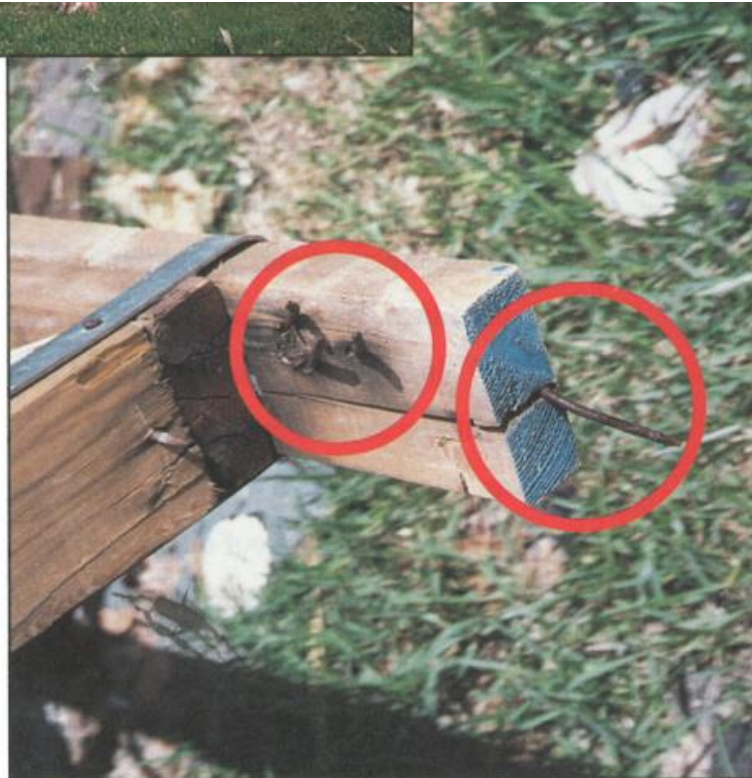
**FIGURE 5.**  
*End of exterior non-loadbearing wall top plate. Transfer of forces on entire wall depended on a limited number of nails.*

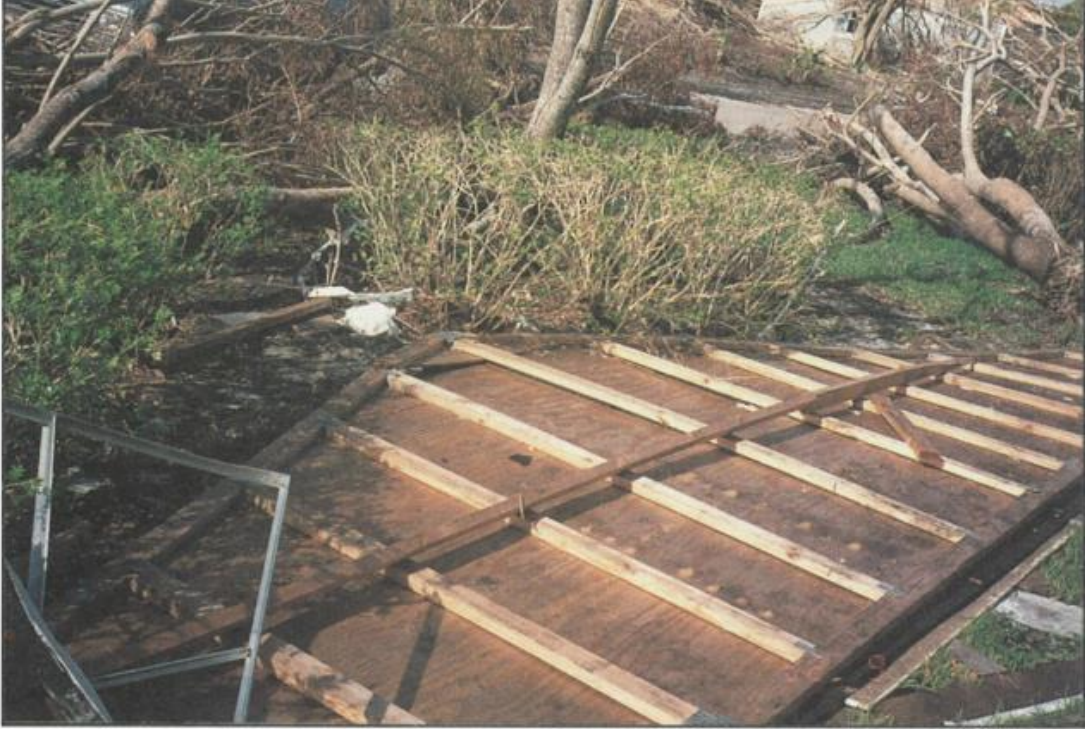
FIGURE 6. Entire wood gable separation. Bracing connection, if completed, may have prevented this from occurring.

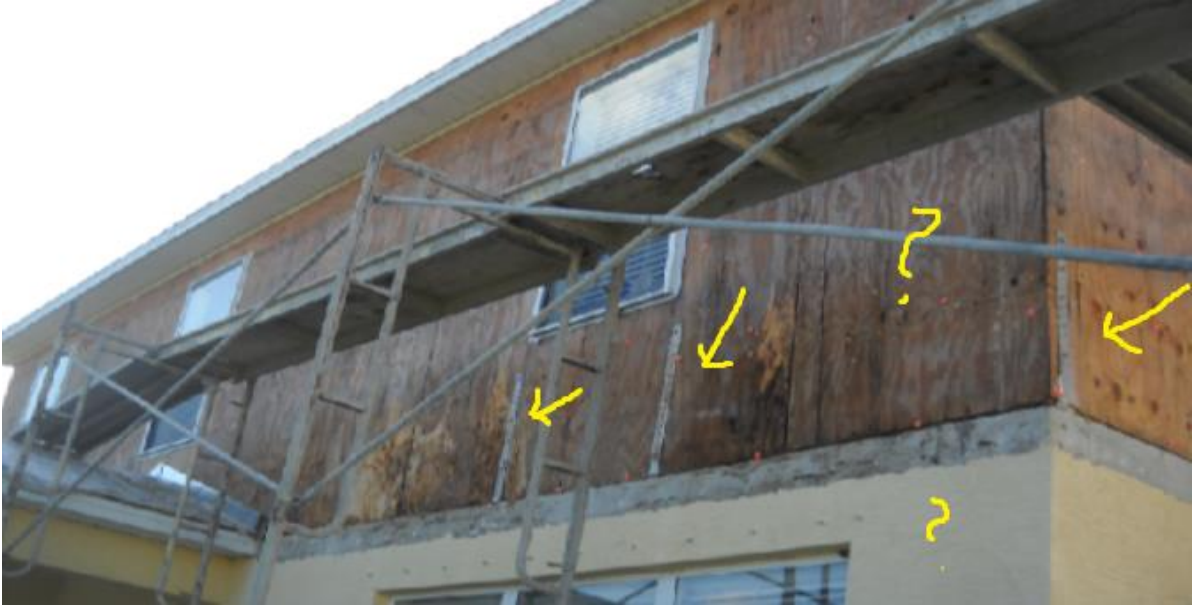
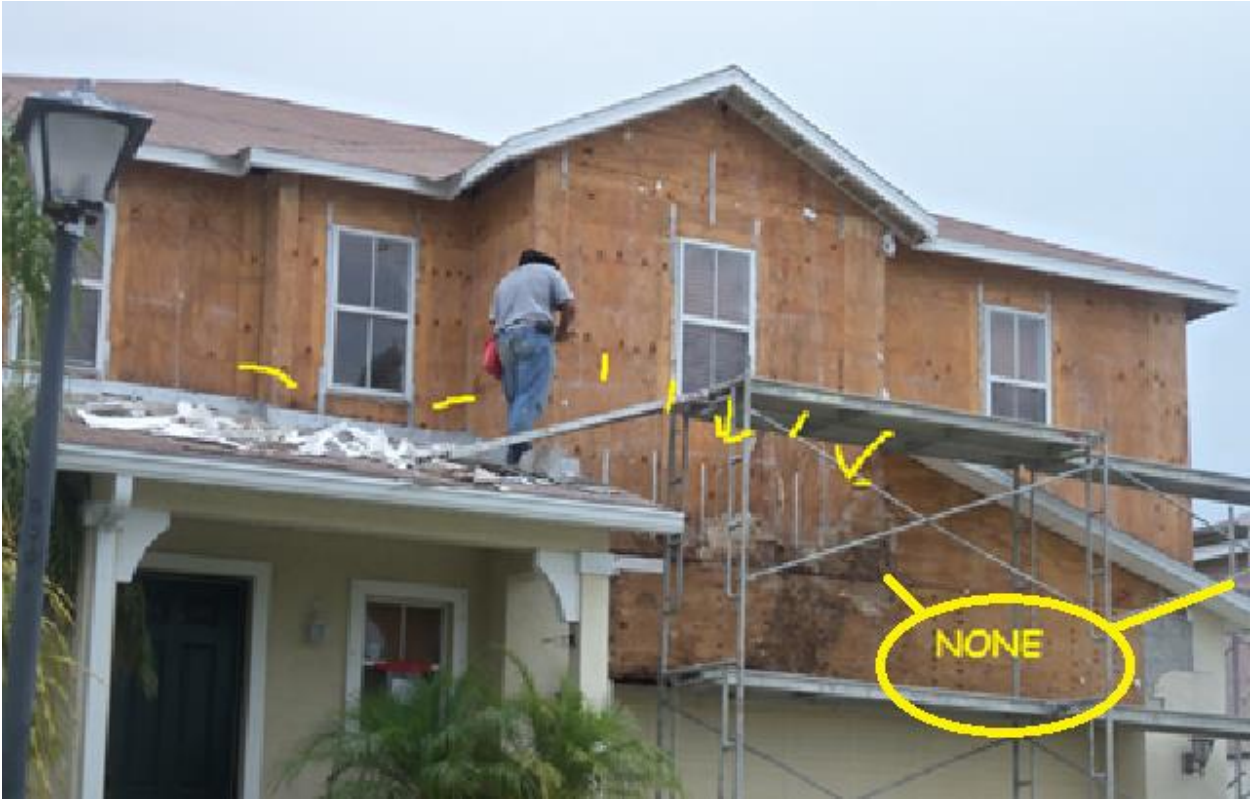
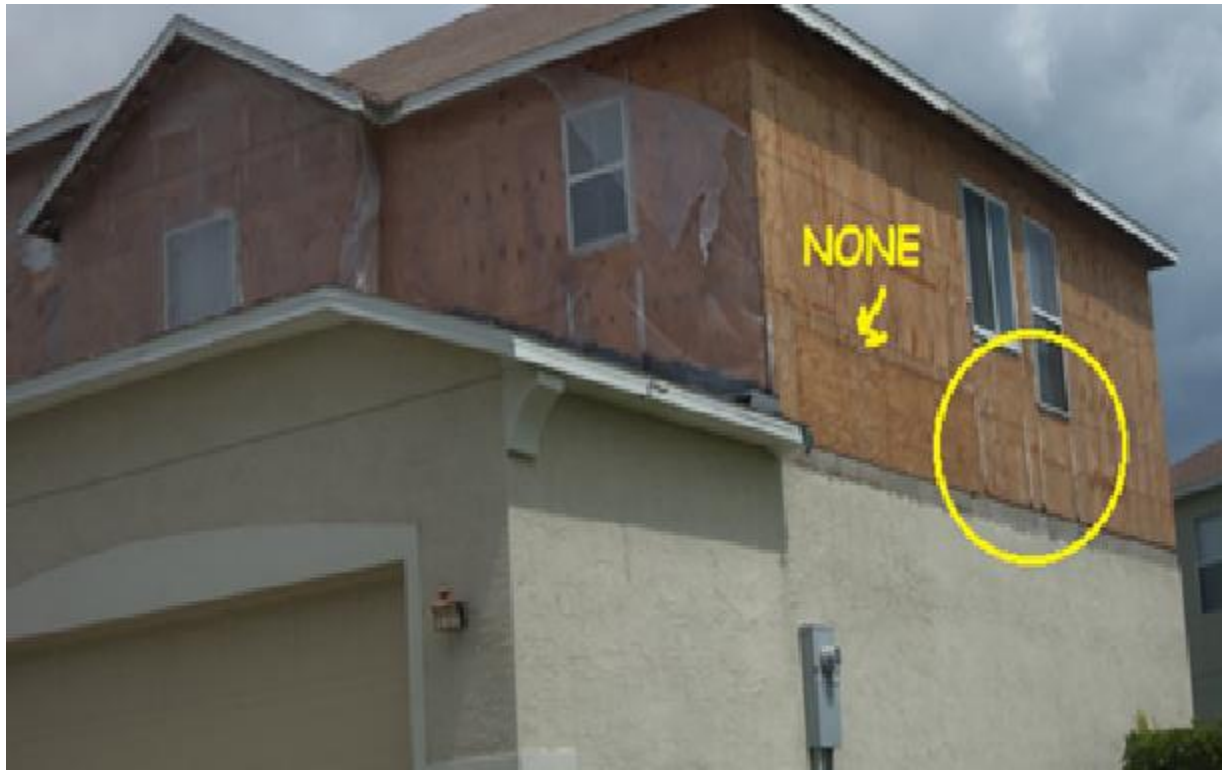
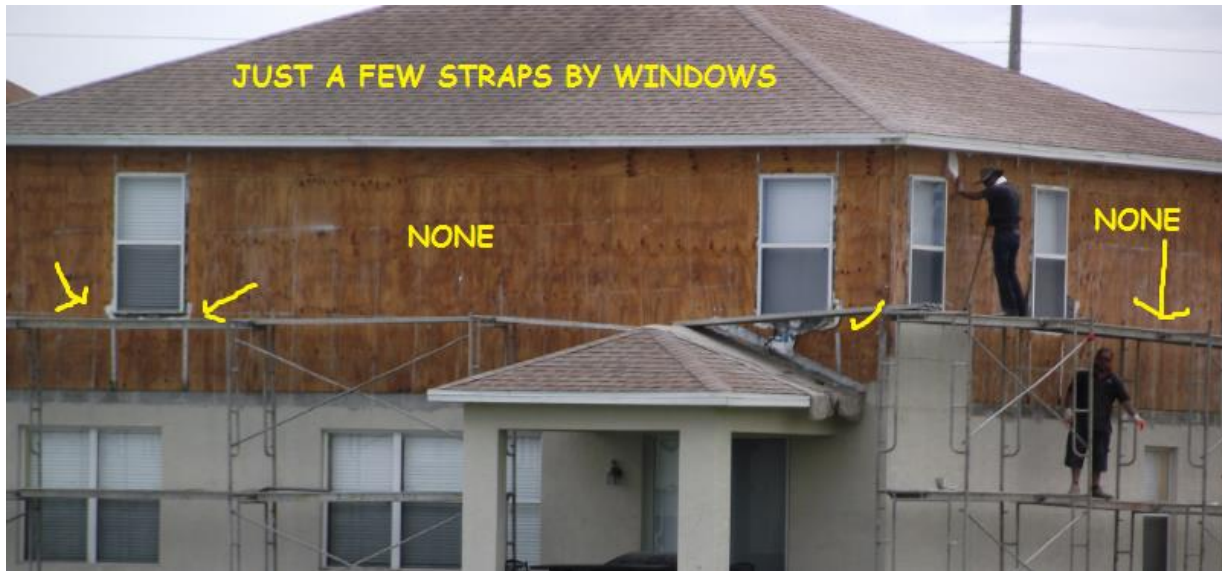
**CARRIAGE LAKE - MISSING STRAPS?**

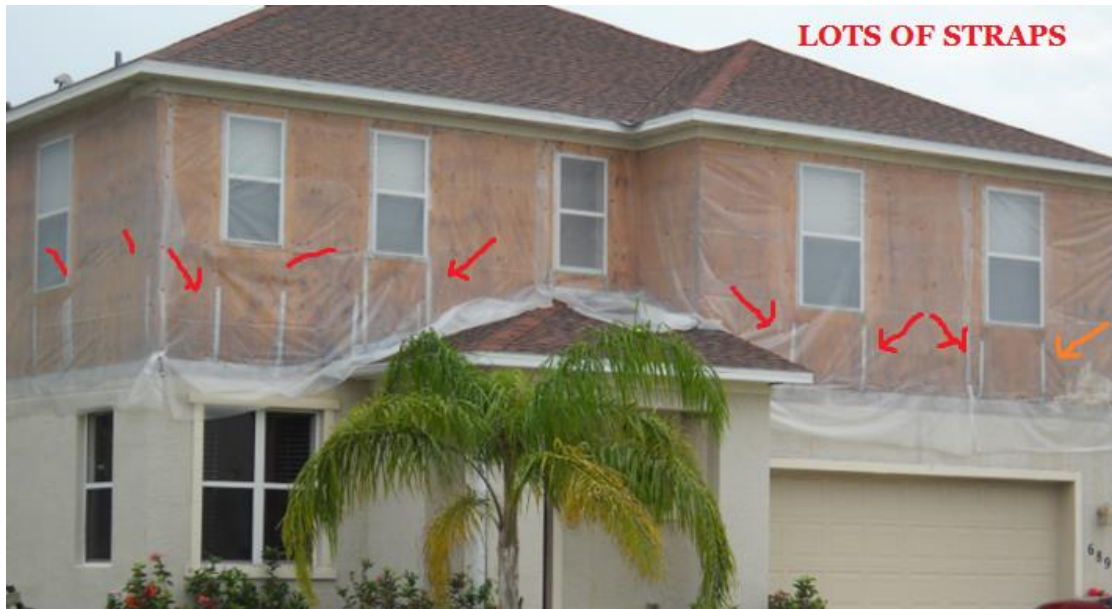
**Is this one above built correctly? Lots of straps**
