1992 GRAND JURY HURRICANE ANDREW

IV. CODE INSPECTIONS

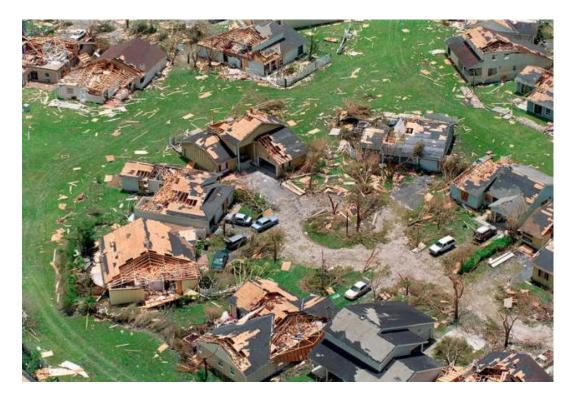
(Arvida Country Walk above)
