**COMPLAINT AND DEMAND FOR JURY TRIAL**

# Inspection Report

## Cement-Based Plaster Stucco Evaluation

*The Hester Residence  
11341 Justin Oaks Dr N  
Jacksonville, FL 32221*

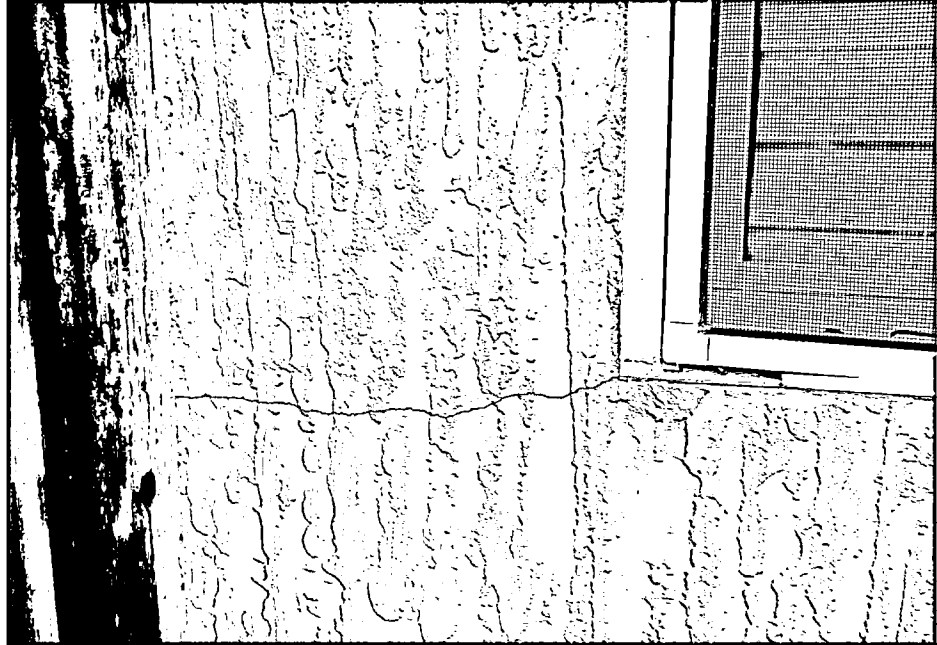
i)

Issue: Cracking in stucco allowing moisture infiltration.

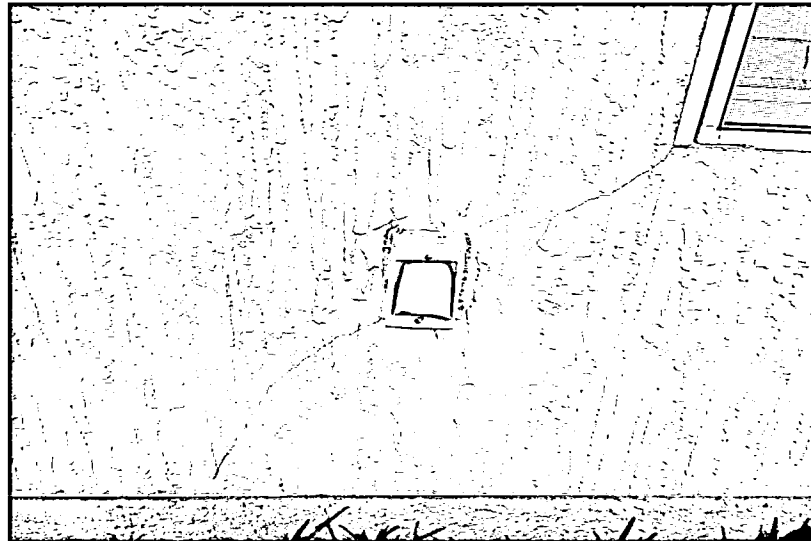
ii)

Issue: Cracking in stucco allowing moisture infiltration.

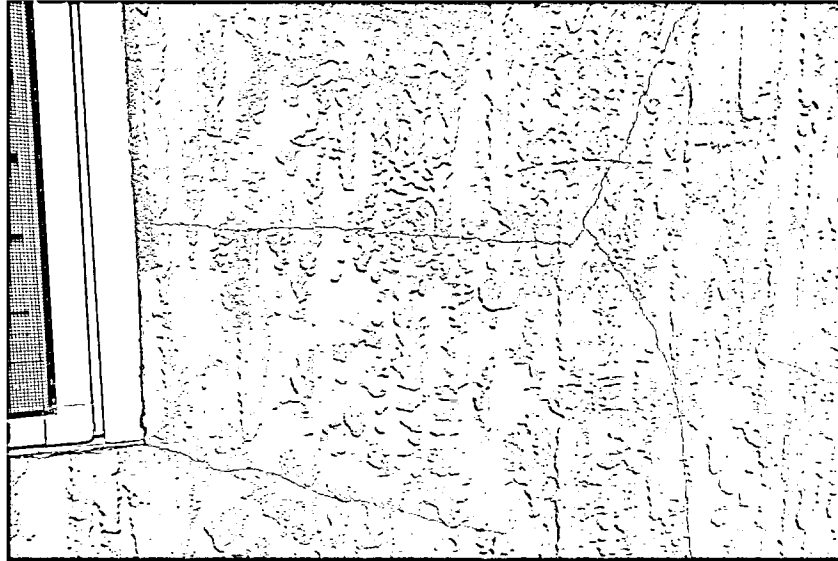
iii)

Issue: Cracking in stucco allowing moisture infiltration.

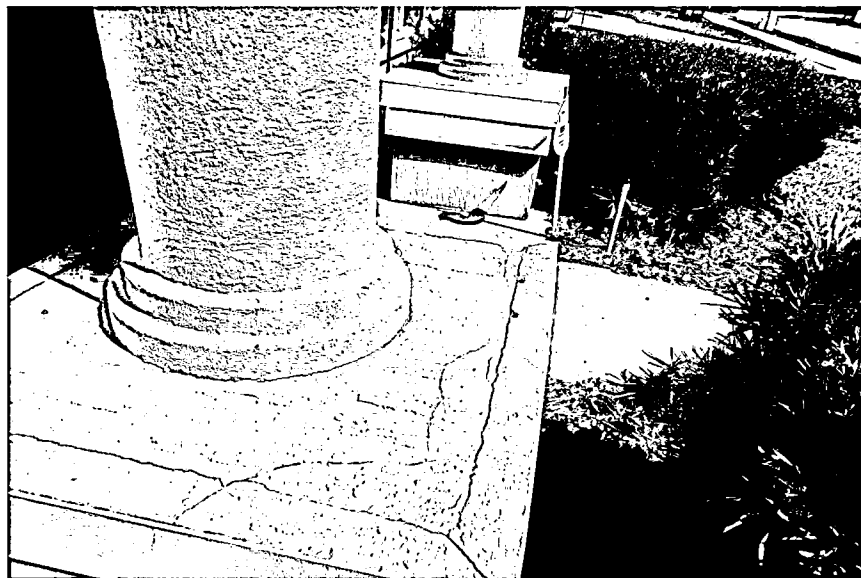
iv)

Issue: Cracking in stucco allowing moisture infiltration.

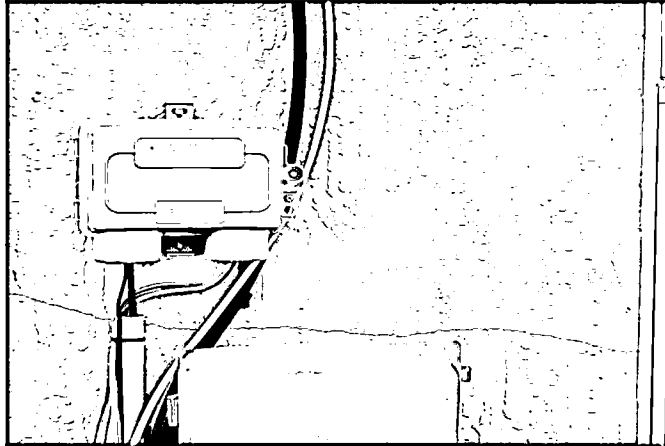
v)

**Issue:** Cracking in stucco allowing moisture infiltration.

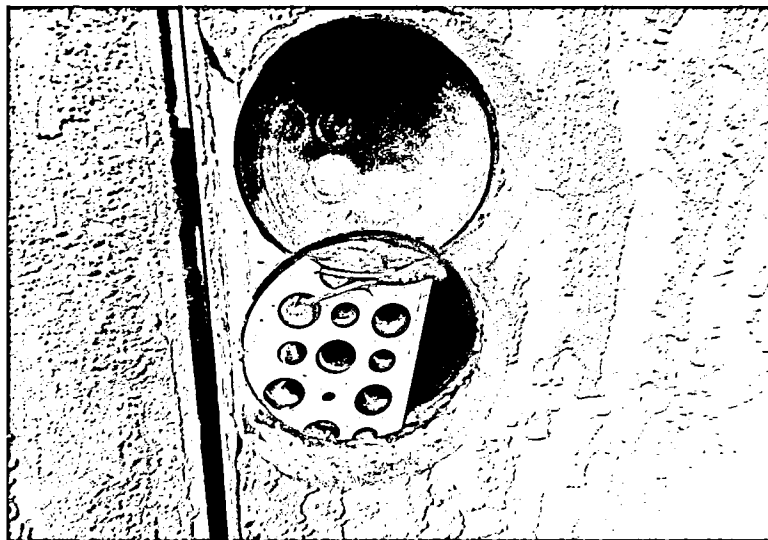
vi)

**Issue:** Lath must be cut and tied to the control joint, otherwise it restricts movement and cracks.

**ASTM C-1063 7.10.1.4 (Lath Behind control joints)** Lath shall not be continuous through control joints but shall be stopped and tied at each side.

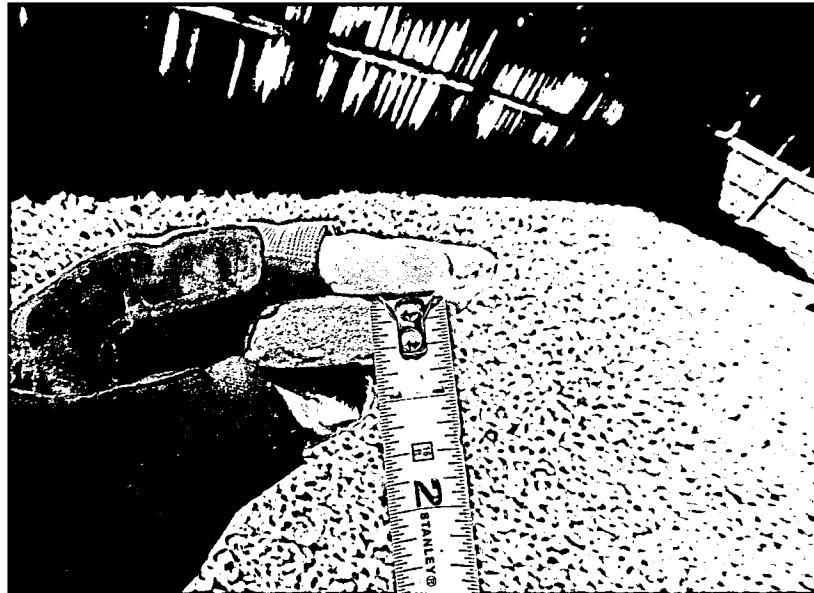
vii)

Issue: The stucco does not meet the thickness required by the standards.

ASTM C 926 Table 4 - Nominal Plaster Thickness - per Table 4, the minimum thickness of stucco installed with metal base over solid base is a 7/8" 3 coat system.

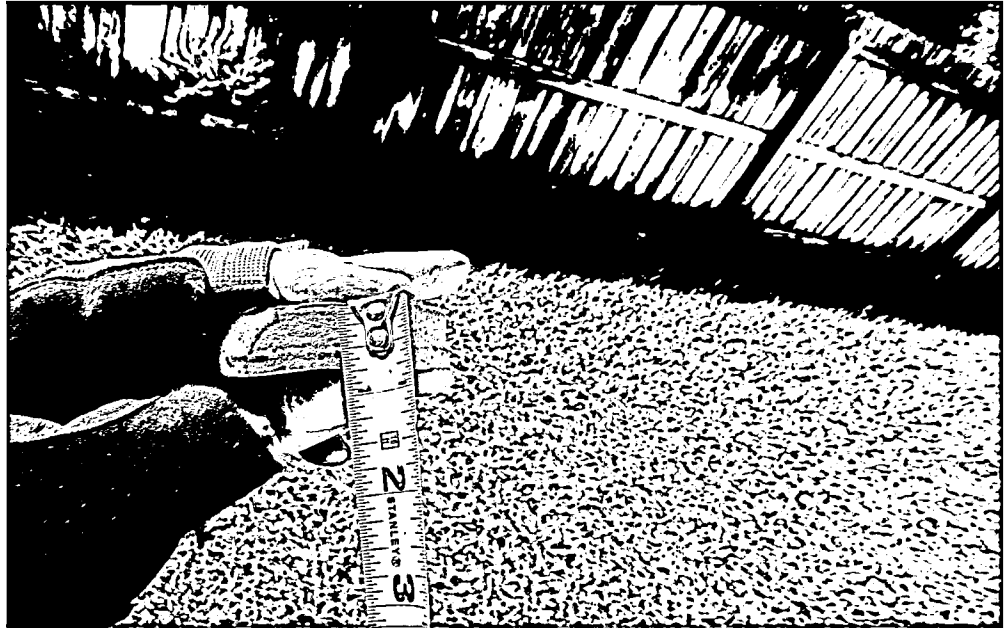
**Issue:** The stucco does not meet the thickness required by the standards.

**ASTM C 926 Table 4 - Nominal Plaster Thickness** - per Table 4, the minimum thickness of stucco installed with metal base over solid base is a 7/8" 3 coat system.

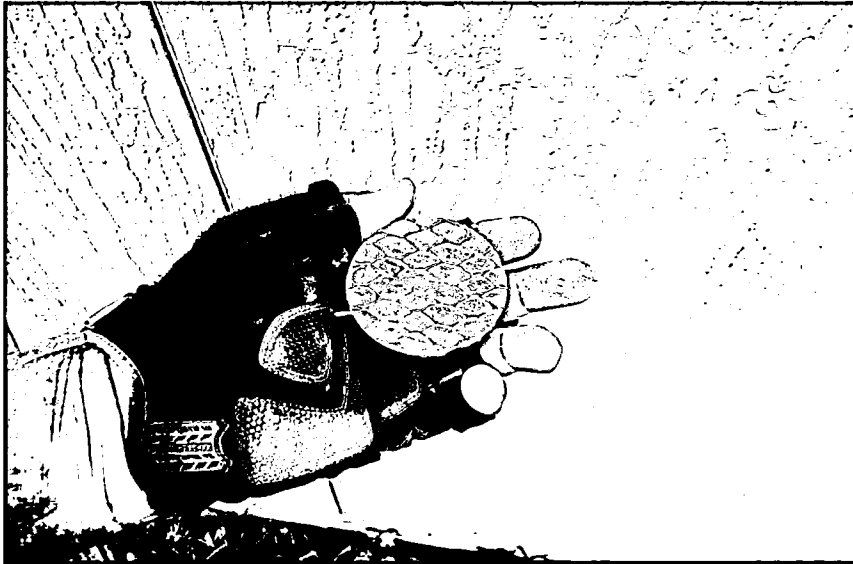
x)

**Issue:** The stucco is not embedded fully into the lath.

**ASTM C926 7.2.1 - (Embedment)** The first (scratch) coat shall be applied with sufficient material and pressure to form full keys through, and to embed the metal base, and with sufficient thickness of material over the metal to allow for scoring the surface.

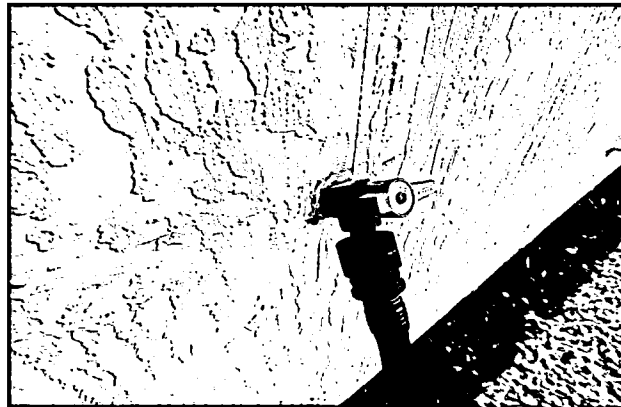
xii)

**Issue:** Dissimilar materials must be separated to allow for expansion and contraction..

**ASTM C 926 7 .1 .4 (Dissimilar Materials)** Separation shall be provided where plaster abuts dissimilar construction materials or openings.

**ASTM C-1063 7.11.3 (dissimilar material)**—Nonload-bearing members shall be isolated from load-bearing members, and all penetrating elements, with casing beads or other suitable means, to avoid transfer of structural loads, and to separate **from dissimilar materials**

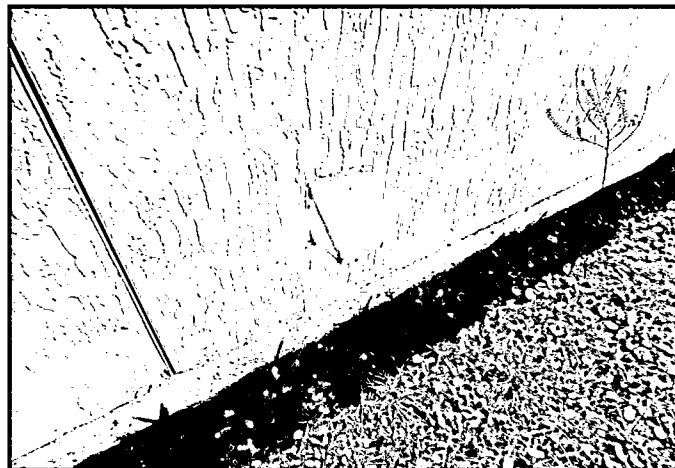
xiii)

**Issue:** Dissimilar materials must be separated to allow for expansion and contraction..

**ASTM C 926 7 .1 .4 (Dissimilar Materials)** Separation shall be provided where plaster abuts dissimilar construction materials or openings.

**ASTM C-1063 7.11.3 (dissimilar material)**—Nonload-bearing members shall be isolated from load-bearing members, and all penetrating elements, with casing beads or other suitable means, to avoid transfer of structural loads, and to separate **from dissimilar materials**

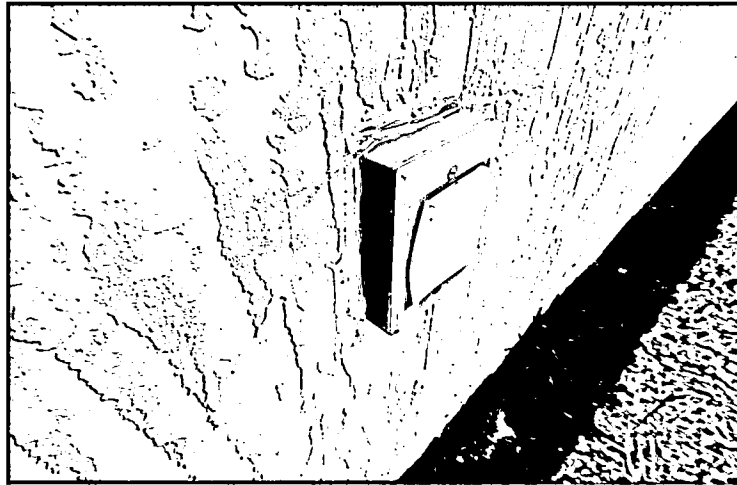
xiv)

**Issue:** Dissimilar materials must be separated to allow for expansion and contraction..

**ASTM C 926 7 .1 .4 (Dissimilar Materials)** Separation shall be provided where plaster abuts dissimilar construction materials or openings.

**ASTM C-1063 7.11.3 (dissimilar material)**—Nonload-bearing members shall be isolated from load-bearing members, and all penetrating elements, with casing beads or other suitable means, to avoid transfer of structural loads, and to separate **from dissimilar materials**

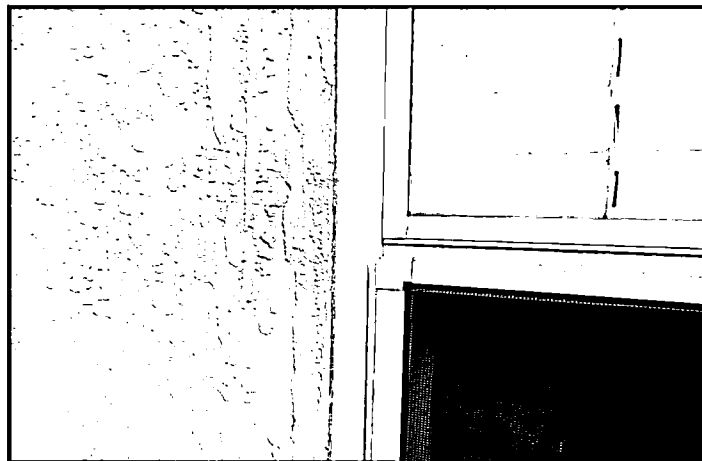
xv)

**Issue:** Dissimilar materials must be separated to allow for expansion and contraction.

**ASTM C 926 7 .1 .4 (Dissimilar Materials)** Separation shall be provided where plaster abuts dissimilar construction materials or openings.

**ASTM C-1063 7.11.3 (dissimilar material)**—Nonload-bearing members shall be isolated from load-bearing members, and all penetrating elements, with casing beads or other suitable means, to avoid transfer of structural loads, and to separate **from dissimilar materials**

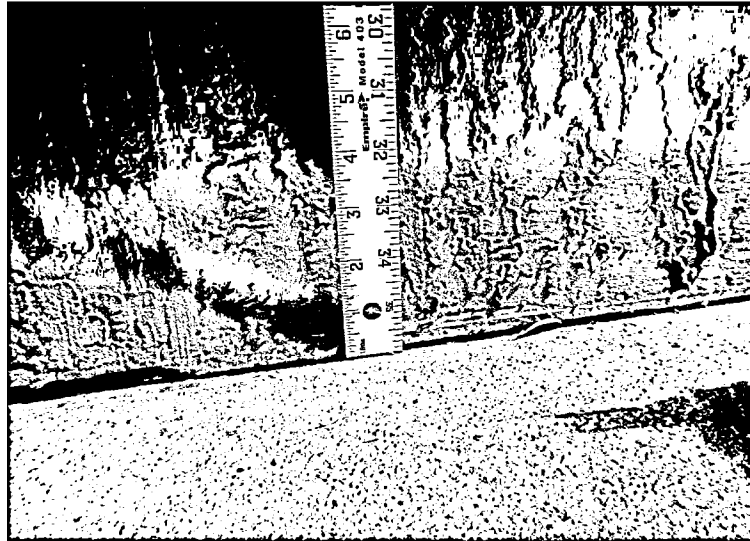
xvi)

**Issue:** A weep screed must be at least 2" above paved surfaces. This is at the same level.

**7.11.5 Foundation Weep ...**The nose of the screed shall be placed ... 2 in. (51 mm) above paved surfaces. The weather resistive barrier and lath shall entirely cover the vertical attachment flange and terminate at the top edge of the nose or ground flange.

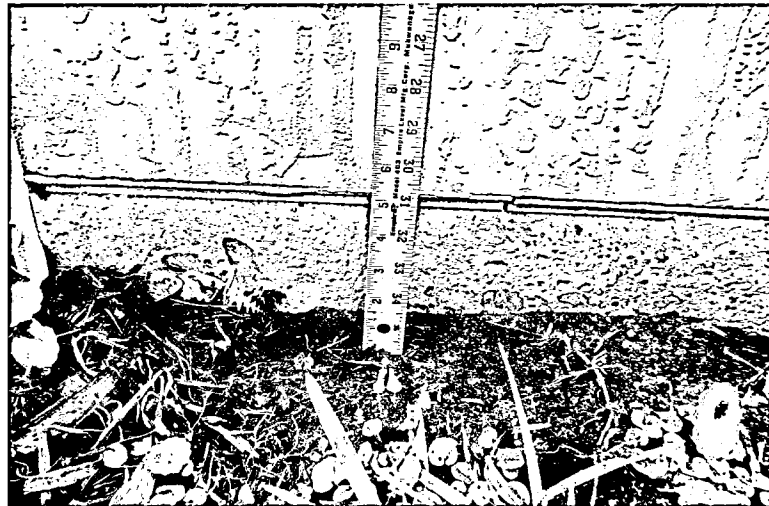
xvii)

**Issue:** A foundation weep screed must be at least 6" above finished grade.

**FBC 1403.8 (Foundation weep screed)** In order to provide for inspection for termite infestation, clearance between exterior wall coverings and final earth grade on the exterior of a building shall not be less than 6 inches (152 mm).
