COMPLAINT AND DEMAND FOR JURY TRIAL

Inspection Report Cement-Based Plaster Stucco Evaluation

The Layne Residence 3894 Marsh Bluff Dr. Jacksonville, FL 32226

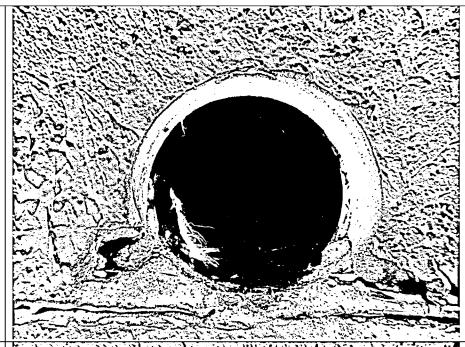
6. Issue: Wood Rot is Present due to Moisture Infiltration

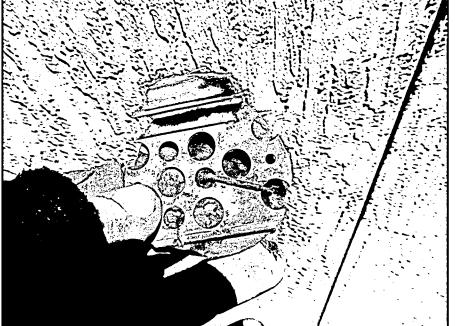
7. Issue: Lath must be cut and tied to the control joint, otherwise it restricts movement and cracks.

ASTM C-1063 7.10.1.4 (Lath Behind control joints) Lath shall not be continuous through control joints but shall be stopped and tied at each side.

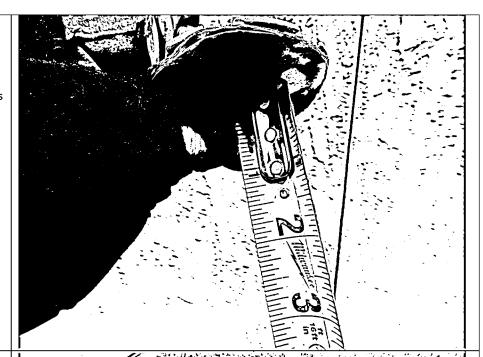
8. Issue: The staples are not long enough to properly fasten the lath to the structural framing.

ASTM C-1063 7.10.2.2 (staples). Staples shall have crowns not less than ¾ in. (19.05 mm) and shall engage not less than three strands of lath and penetrate the wood framing members not less than ¾ in (19.05 mm). When metal lath is applied over sheathing, use fasteners that will penetrate the structural members not less than ¾ in. (19

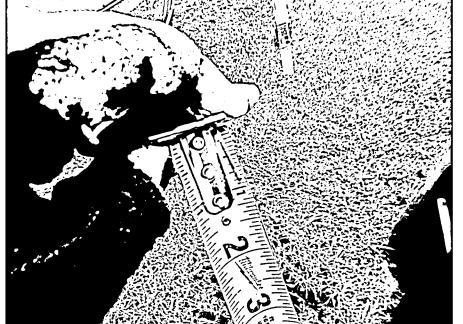
9. Issue: The staples are not long enough to properly fasten the lath to the structural framing.

ASTM C-1063 7.10.2.2 (staples). Staples shall have crowns not less than ¾ in. (19.05 mm) and shall engage not less than three strands of lath and penetrate the wood framing members not less than ¾ in (19.05 mm). When metal lath is applied over sheathing, use fasteners that will penetrate the structural members not less than ¾ in. (19 mm).

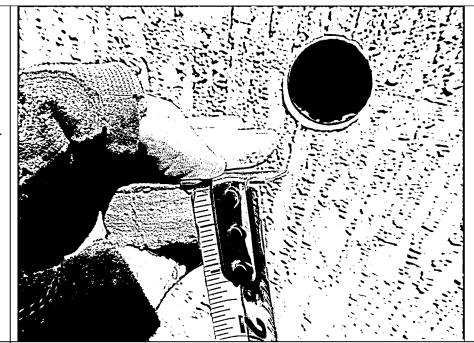
10. Issue: The stucco does not meet the thickness required by the standards.

ASTM C 926 Table 4 - Nominal Plaster Thickness - per Table 4, the minimum thickness of stucco installed with metal base over solid base is a 7/8" 3 coat system.

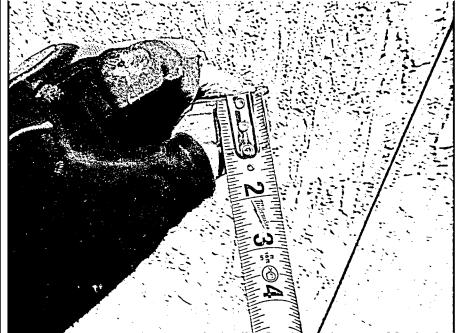
11. Issue: The stucco does not meet the thickness required by the standards.

ASTM C 926 Table 4 - Nominal Plaster Thickness - per Table 4, the minimum thickness of stucco installed with metal base over solid base is a 7/8" 3 coat system.

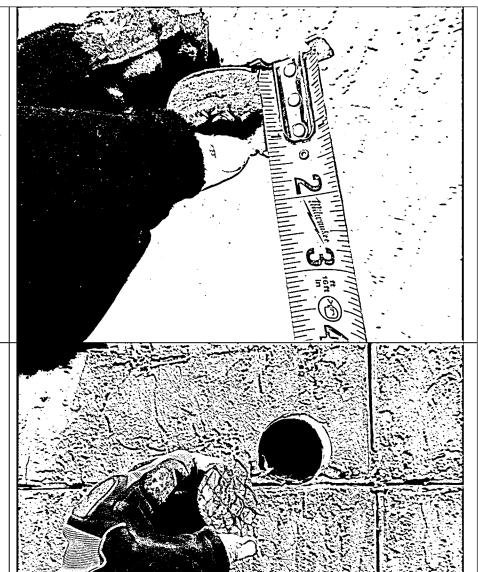
12. Issue: The stucco does not meet the thickness required by the standards.

ASTM C 926 Table 4 - Nominal Plaster Thickness - per Table 4, the minimum thickness of stucco installed with metal base over solid base is a 7/8" 3 coat system.

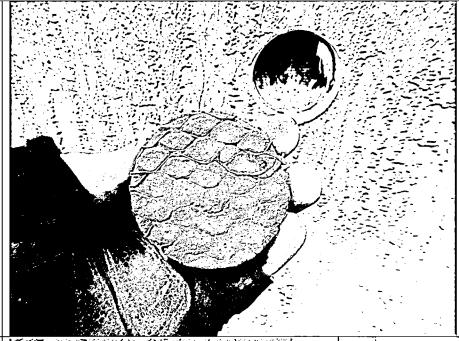
ASTM C926 7.2.1 - (Embedment)

ASTM C926 7.2.1 - (Embedment)
The first (scratch) coat shall be applied with sufficient material and pressure to form full keys through, and to embed the metal base, and with sufficient thickness of material over the metal to allow for scoring the surface.

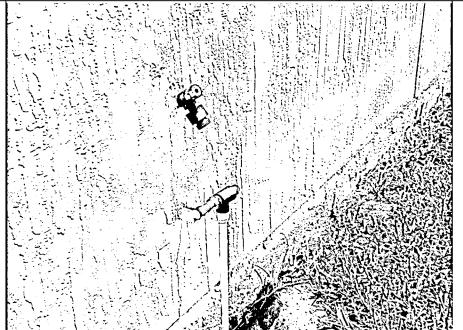
17. Issue: Dissimilar materials must be separated to allow for expansion and contraction.

ASTM C 926 7 .1 .4 (Dissimilar Materials) Separation shall be provided where plaster abuts dissimilar construction materials or openings.

ASTM C-1063 7.11.3 (dissimilar material)—Nonload-bearing members shall be isolated from load-bearing members, and all penetrating elements, with casing beads or other suitable means, to avoid transfer of structural loads, and to separate from dissimilar materials

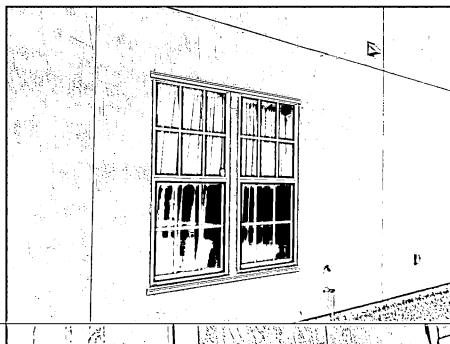
18. Issue: Dissimilar materials must be separated to allow for expansion and contraction.

ASTM C 926 7 .1 .4 (Dissimilar Materials) Separation shall be provided where plaster abuts dissimilar construction materials or openings.

ASTM C-1063 7.11.3 (dissimilar material)—Nonload-bearing members shall be isolated from load-bearing members, and all penetrating elements, with casing beads or other suitable means, to avoid transfer of structural loads, and to separate from dissimilar materials

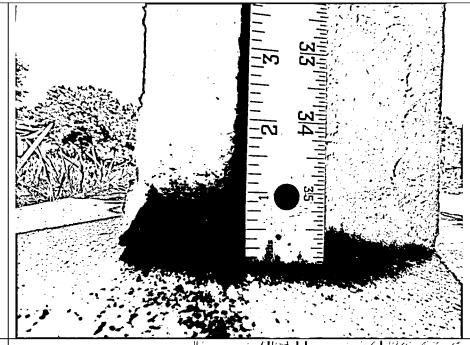
20. Issue: A weep screed must be at least 2" above paved surfaces.
This is at the same level.

7.11.5 Foundation Weep ... The nose of the screed shall be placed ... 2 in. (51 mm) above paved surfaces. The weather resistive barrier and lath shall entirely cover the vertical attachment flange and terminate at the top edge of the nose or ground flange
