COMPLAINT AND DEMAND FOR JURY TRIAL

Inspection Report Cement-Based Plaster Stucco Evaluation

The Griffin Residence 7496 Steventon Way Jacksonville, FL 32244

The Guan Residence 6339 Whitby Ct Jacksonville, FL 32244

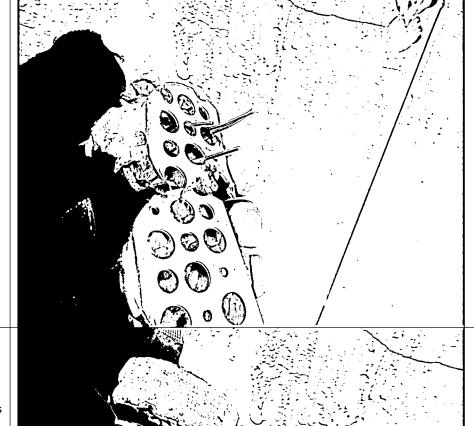
8. Issue: Lath must be cut and tied to the control joint, otherwise it restricts movement and cracks.

ASTM C-1063 7.10.1.4 (Lath Behind control joints) Lath shall not be continuous through control joints but shall be stopped and tied at each side.

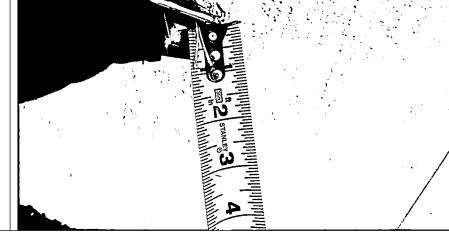
9. Issue: The staples are not long enough to properly fasten the lath to the structural framing.

ASTM C-1063 7.10.2.2 (staples). Staples shall have crowns not less than ¾ in. (19.05 mm) and shall engage not less than three strands of lath and penetrate the wood framing members not less than ¾ in (19.05 mm). When metal lath is applied over sheathing, use fasteners that will penetrate the structural members not less than ¾ in. (19 mm).

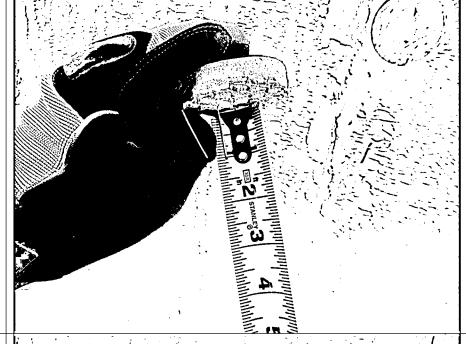
10. Issue: The staples are not long enough to properly fasten the lath to the structural framing.

ASTM C-1063 7.10.2.2 (staples). Staples shall have crowns not less than ¾ in. (19.05 mm) and shall engage not less than three strands of lath and penetrate the wood framing members not less than ¾ in (19.05 mm). When metal lath is applied over sheathing, use fasteners that will penetrate the structural members not less than ¾ in. (19 mm).

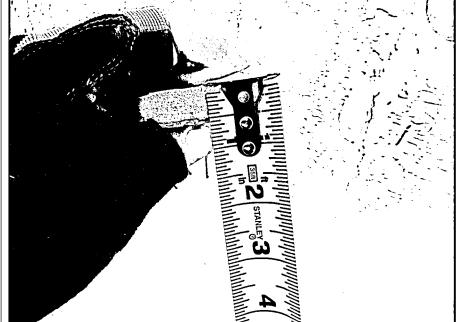
11. Issue: The stucco does not meet the thickness required by the standards.

ASTM C 926 Table 4 - Nominal Plaster Thickness - per Table 4, the minimum thickness of stucco installed with metal base over solid base is a 7/8" 3 coat system.

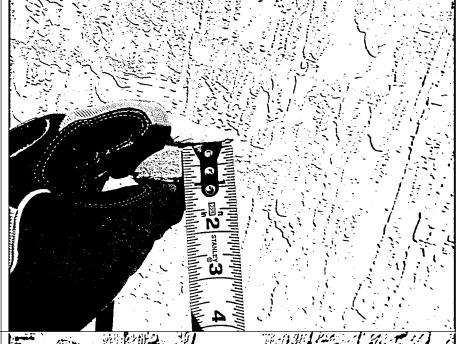
12. Issue: The stucco does not meet the thickness required by the standards.

ASTM C 926 Table 4 - Nominal Plaster Thickness - per Table 4, the minimum thickness of stucco installed with metal base over solid base is a 7/8" 3 coat system.

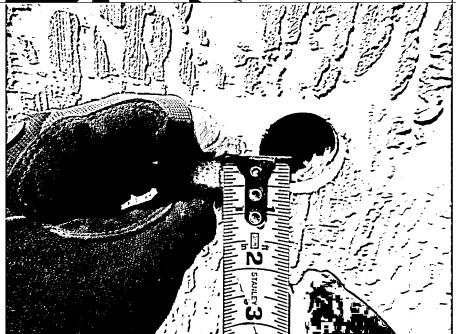
13. Issue: The stucco does not meet the thickness required by the standards.

ASTM C 926 Table 4 - Nominal Plaster Thickness - per Table 4, the minimum thickness of stucco installed with metal base over solid base is a 7/8" 3 coat system.

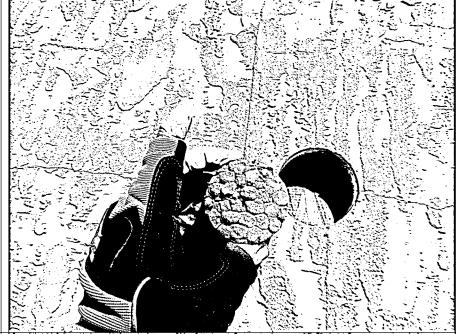
14. Issue: The stucco is not embedded fully into the lath.

ASTM C926 7.2.1 - (Embedment)
The first (scratch) coat shall be
applied with sufficient material
and pressure to form full keys
through, and to embed the metal
base, and with sufficient
thickness of material over the
metal to allow for scoring the
surface.

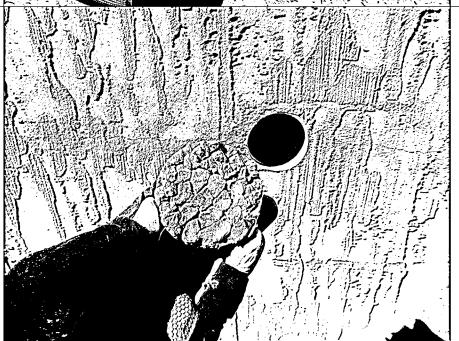
15. Issue: The stucco is not embedded fully into the lath.

ASTM C926 7.2.1 - (Embedment)
The first (scratch) coat shall be
applied with sufficient material
and pressure to form full keys
through, and to embed the metal
base, and with sufficient
thickness of material over the
metal to allow for scoring the
surface.

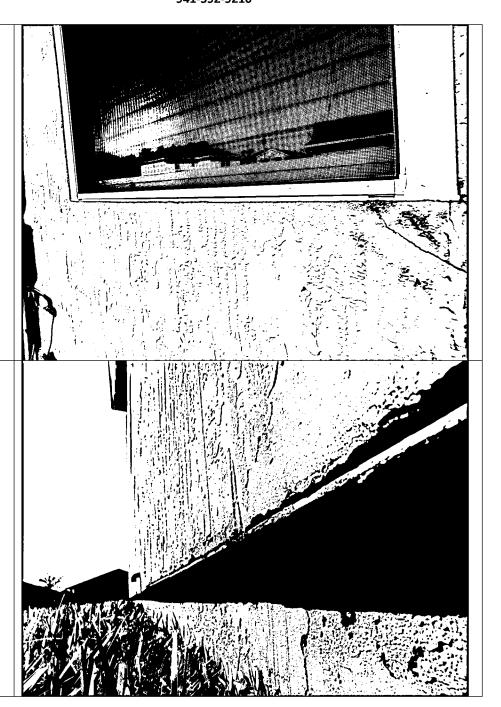
17. Issue: Dissimilar materials must be separated to allow for expansion and contraction.

ASTM C 926 7 .1 .4 (Dissimilar Materials) Separation shall be provided where plaster abuts dissimilar construction materials or openings.

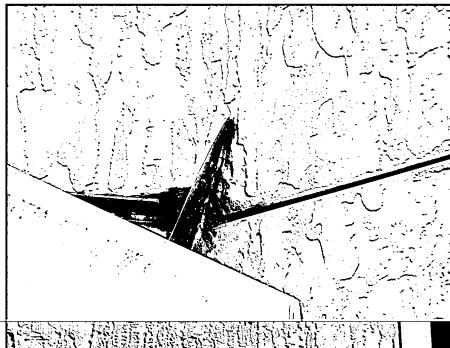
18. Issue: Dissimilar materials must be separated to allow for expansion and contraction.

ASTM C 926 7.1.4 (Dissimilar Materials) Separation shall be provided where plaster abuts dissimilar construction materials or openings.

ASTM C-1063 7.11.3 (dissimilar material)—Nonload-bearing members shall be isolated from load-bearing members, and all penetrating elements, with casing beads or other suitable means, to avoid transfer of structural loads, and to separate from dissimilar materials

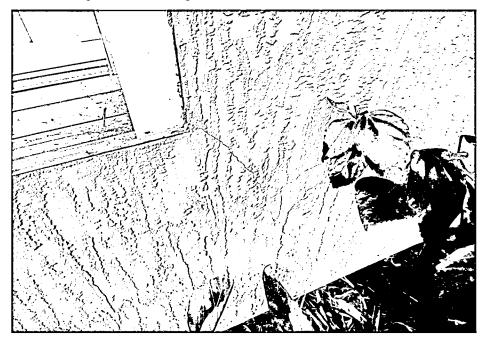
i)

Issue: Cracking in stucco allowing moisture infiltration.

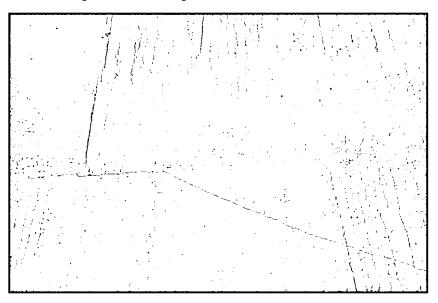
iii)

Issue: Cracking in stucco allowing moisture infiltration.

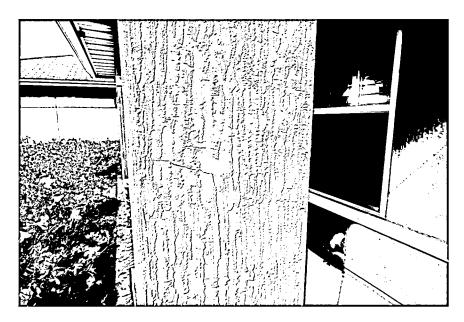
iv)

Issue: Cracking in stucco allowing moisture infiltration.

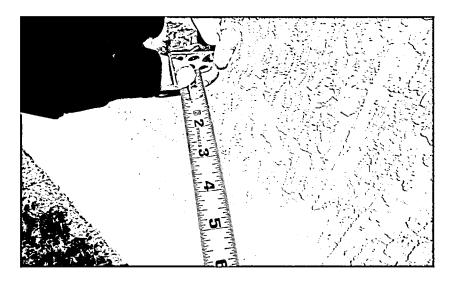
vii)

Issue: The staples are not long enough to properly fasten the lath to the structural framing.

ASTM C-1063 7.10.2.2 (staples) .. Staples shall have crowns not less than $\frac{3}{4}$ in. (19.05 mm) and shall engage not less than three strands of lath and penetrate the wood framing members not less than $\frac{3}{4}$ in (19.05 mm). When metal lath is applied over sheathing, use fasteners that will penetrate the structural members not less than $\frac{3}{4}$ in. (19 mm).

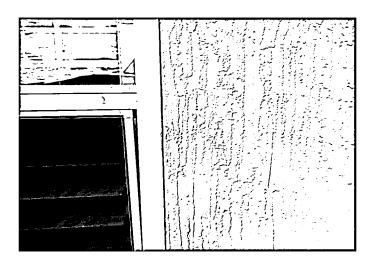
Issue: Dissimilar materials must be separated to allow for expansion and contraction..

ASTM C 926 7 .1 .4 (Dissimilair Materials) Separation shall be provided where plaster abuts dissimilar construction materials or openings.

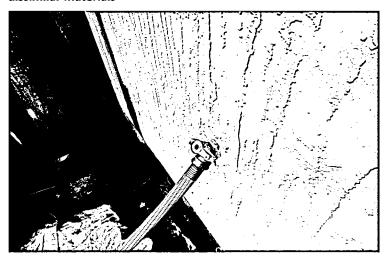
ASTM C 926 7 .1 .4 (Dissimilair Materials) Separation shall be provided where plaster abuts dissimilar construction materials or openings.

ASTM C-1063 7.11.3 (dissimilar material)—Nonload-bearing members shall be isolated from load-bearing members, and all penetrating elements, with casing beads or other suitable means, to avoid transfer of structural loads, and to separate **from dissimilar materials**

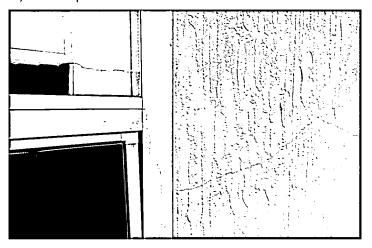
xiii)

Issue: Dissimilar materials must be separated to allow for expansion and contraction.

ASTM C 926 7 .1 .4 (Dissimilair Materials) Separation shall be provided where plaster abuts dissimilar construction materials or openings.

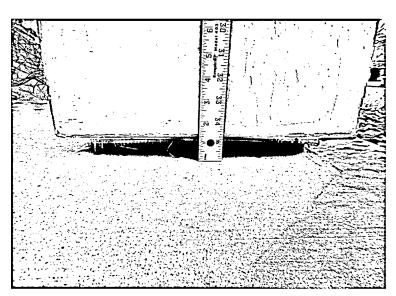
Issue: A weep screed must be at least 2" above paved surfaces. This is at the same level.

7.11.5 Foundation Weep ... The nose of the screed shall be placed ... 2 in. (51 mm) above paved surfaces. The weather resistive barrier and lath shall entirely cover the vertical attachment flange and terminate at the top edge of the nose or ground flange.

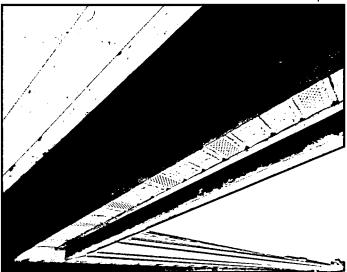
xv)

Issue: A weeping accessory must be present at any horizontal and vertical intersection to allow moisture to exit.

ASTM C 926 section A2.2.3 states: (horizontal and vertical intersection) - Where vertical and horizontal exterior plaster surfaces meet, both surfaces shall be terminated with casing beads with the vertical surface extending at least ¼ in. (6 mm) below the intersecting horizontal plastered surface, thus providing a drip edge. The casing bead for the horizontal surface shall be terminated not less than ¼ in. from the back of the vertical surface to provide drainage.
